PRELIMINARY REPORT

**ACCIDENT TO M/S VSR VENTURES PVT. LTD. LEARJET 45XR AIRCRAFT
BEARING REGISTRATION VT-SSK AT BARAMATI ON 28 JANUARY 2026**

**Government of India
Ministry of Civil Aviation
Aircraft Accident Investigation Bureau**

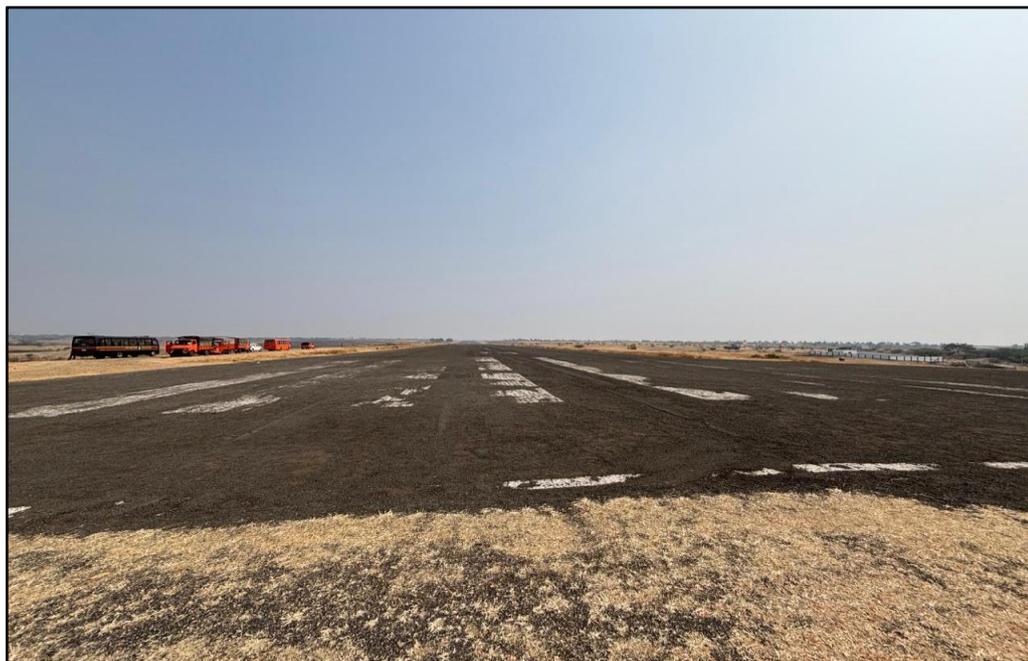
- Only Visual Flight Rules (VFR) operations can be carried out. However, regular flying training operations and Non-scheduled operations are carried out in the airport.
- One end of the runway (beginning of RWY 11) is table top.
- MADC is the present aerodrome operator since August 2025.
- Baramati airport does not have an inhouse ARFF (Aircraft Rescue & Fire Fighting) unit, hence, based on request from non-scheduled operators/ charter flights, Ambulance and firefighting service are provided by Baramati Municipal Corporation on the request made by the aerodrome operator.
- The last runway re-carpeting was carried out in March 2016 and thereafter no runway re-carpeting was carried out which resulted into fading of all the runway markings and presence of loose gravels on the runway surface.

Figure 1: Faded Runway Markings at Runway-11 end.

a. It is recommended that, DGCA may issue specific directions to all the stakeholders responsible to manage and maintain the uncontrolled airfields to ensure that required safety standards are maintained at the airport for safe aircraft operations. Compliance of the same may be checked during audit/surveillance.

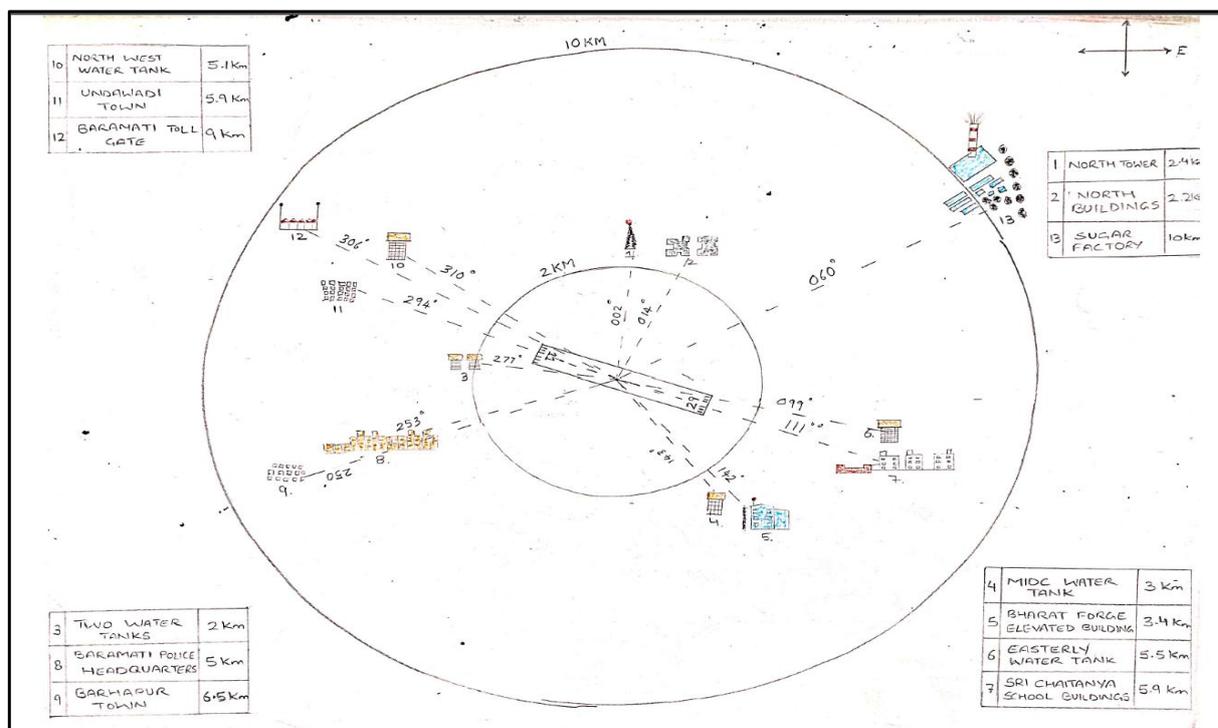
There is no MET facility available at Baramati Airfield. The weather information such as winds, temperature, QNH is generally passed on to the aircraft with the help of a weather instrument installed in the temporary tower of M/s Carver Aviation. There are two wind socks installed in the aerodrome towards runway 29 side. The visibility information is issued to the aircraft based on the visibility chart prepared by the flying training organizations having identified different visibility markers (such as permanent structures) at various locations around the airfield for flying training operations. The visibility chart used by the organisation is shown in figure 2 below.

Figure 2: Chart of Visibility markers used at Baramati

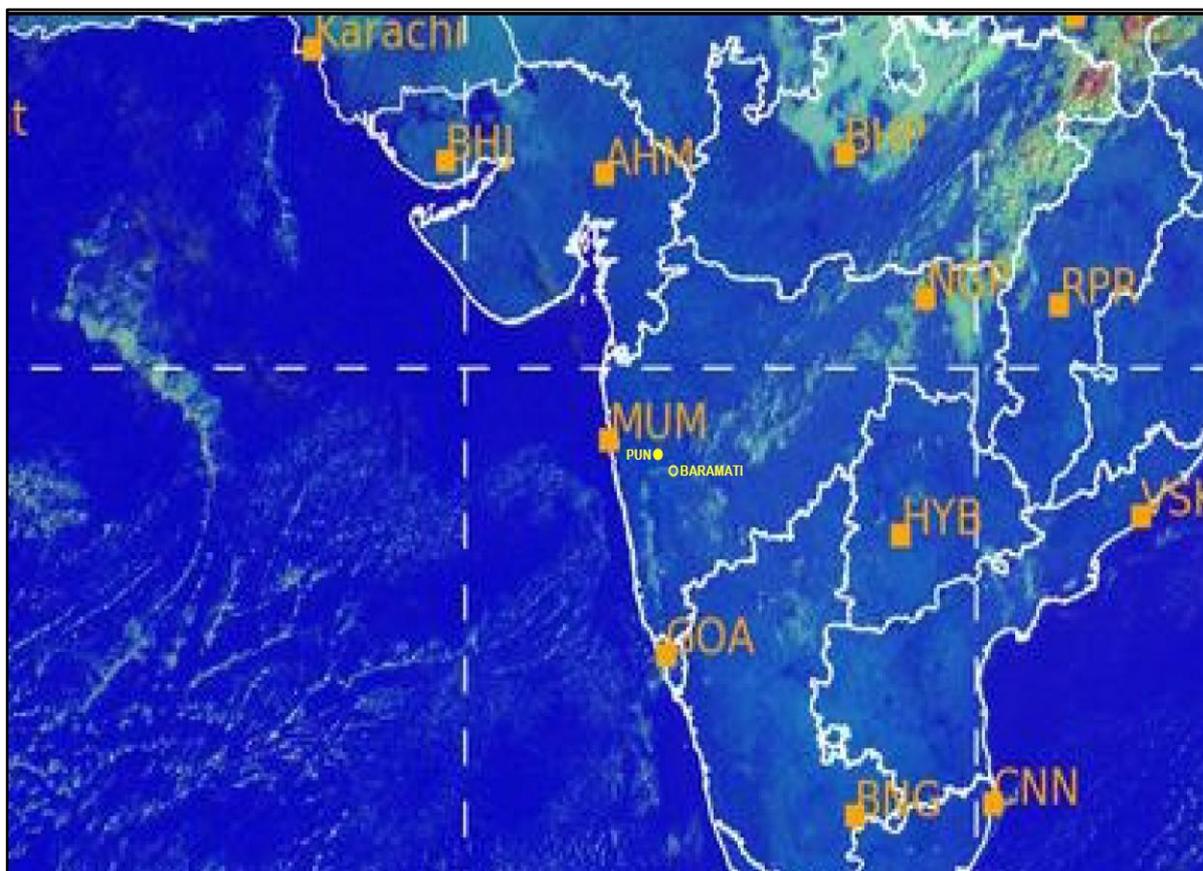
As per INSAT-3DR colour composite of 28 January 2026 between 0315 to 0342 UTC (see figure 3 below), no significant clouding is seen over in and around Pune. However, over Baramati which is in a radial of 120 degree and 81 Km from Pune airfield, presence of very shallow Fog in patches can be inferred.

Figure 3: INSAT-3DR snapshot of 28 January 2026 between 0315 to 0342 UTC

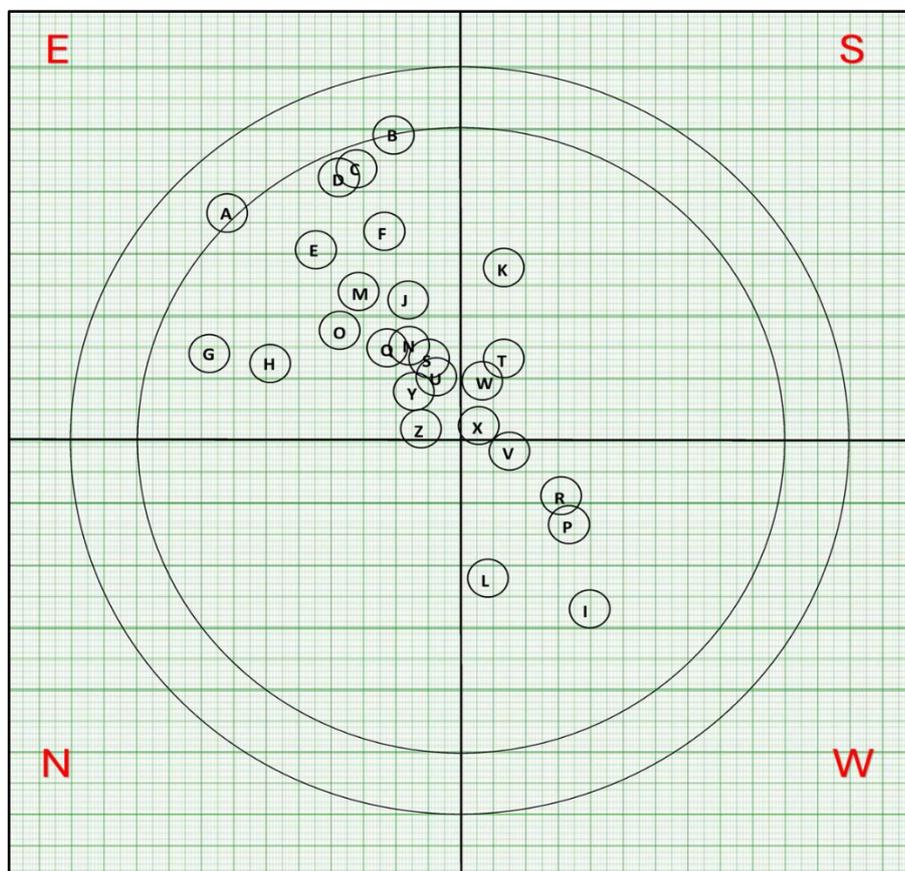
The aircraft was attempting to land on runway 11 after obtaining landing clearance by Baramati tower. The aircraft, however, crash landed on the left of the runway abeam threshold of runway 11. As per the CCTV footages installed in nearby village, the aircraft was observed to have banked towards right before impacting the terrain. The aircraft first impacted the trees before hitting the ground which is at a lower elevation than the runway surface. The ground impact of aircraft was at a lateral distance of about 50 meters on the left from edge of RWY 11. The aircraft was engulfed in fire during which the entire cockpit and cabin section got burnt. The aircraft was destroyed during the accident. The wreckage distribution chart at the accident site is given in figure 4 below.

**Figure 4: Wreckage distribution chart (Not to scale)
(Distances in feet with empennage as reference)**

The tail portion (Empennage) was the major airframe part which was recovered from the site and was located near the final impact point of the aircraft with ground. The pictures of some major identifiable parts of the aircraft at the accident site is provided in Annexure A of the report.

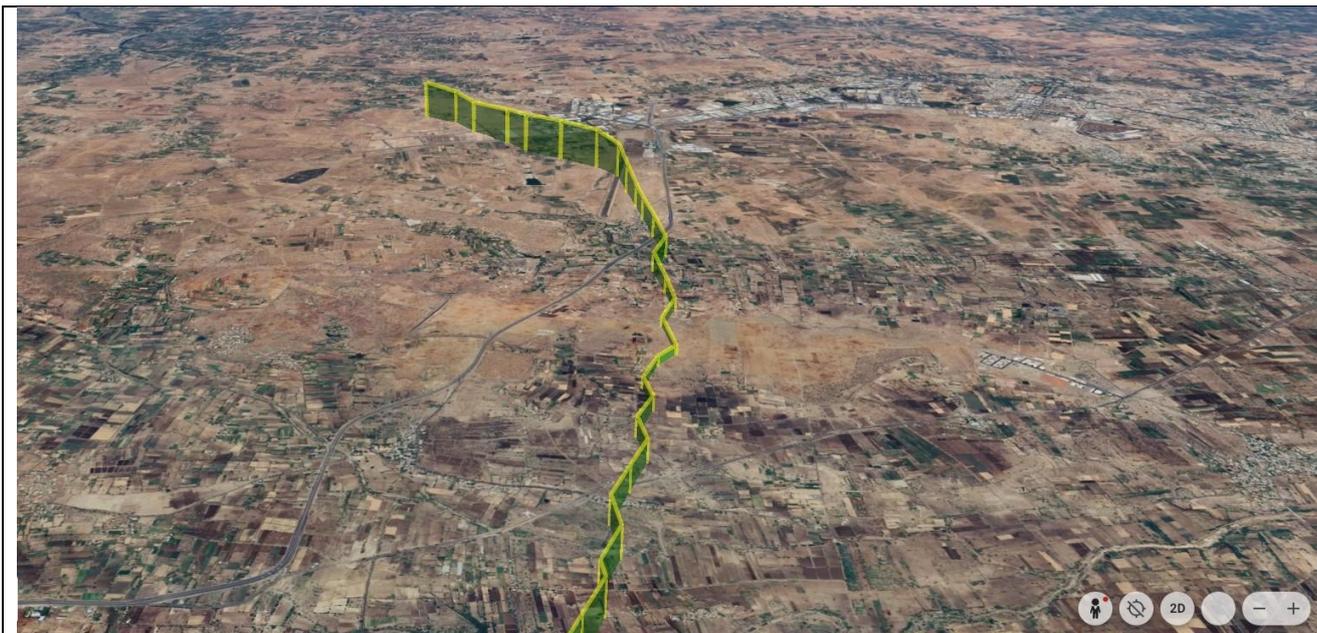
Figure 5a: The probable flight path for first approach and initiation of Go-Around

The figure 5a & 5b above is the probable flight path followed by the aircraft after initiating go-around till the time of accident as per the preliminary DFDR data analysis.

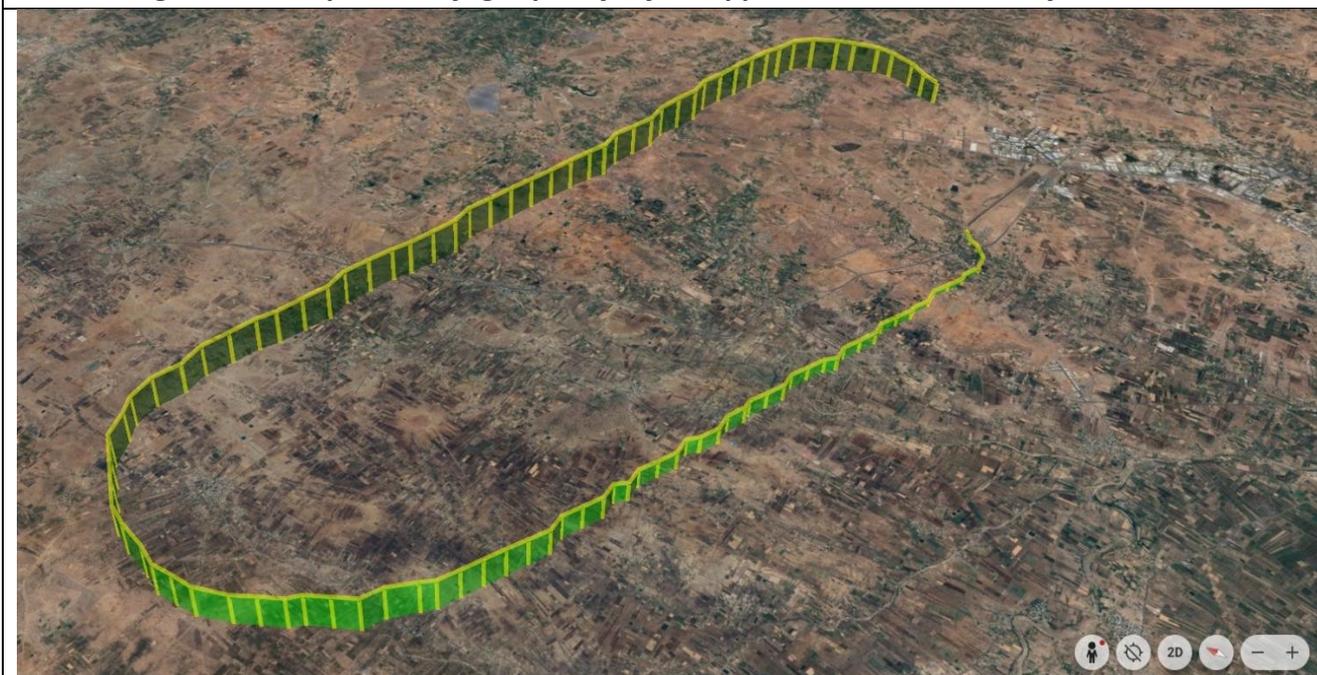
The controller informs visibility as 3 Kms. However, the aircraft continued approach and subsequently carried out go-around. During the second approach the aircraft reported field in sight and subsequently landing clearance was given by the Baramati tower for runway 11. The tower also informed the winds as calm. Later the aircraft was heard transmitting "Oh S**t... Oh S**t...", before it crash landed on the left side of the runway abeam runway 11 threshold.

Figure 5b: Probable Flight path of the Aircraft after initiating go-around till accident.

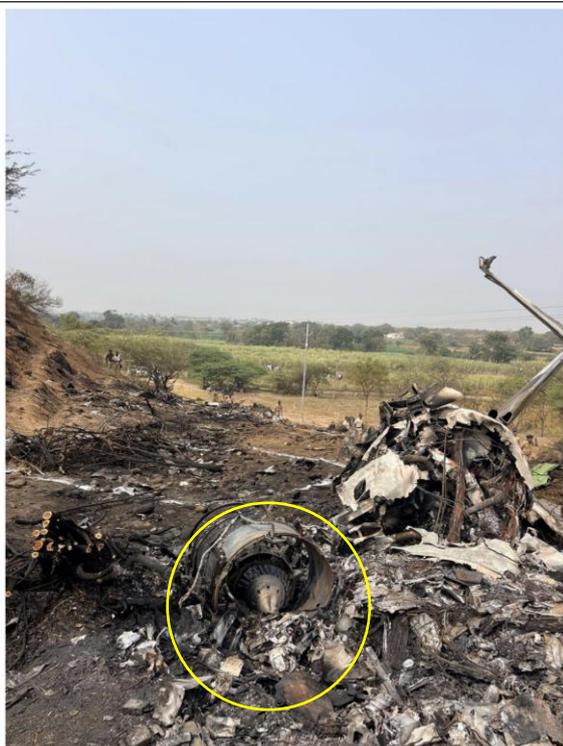
Annexure "A"**RH Engine and Empennage**

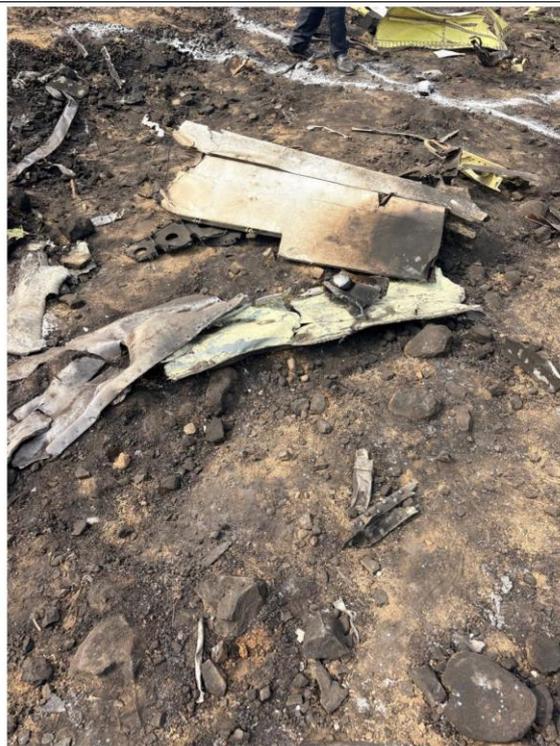
**RH Servo Tab and Wing**

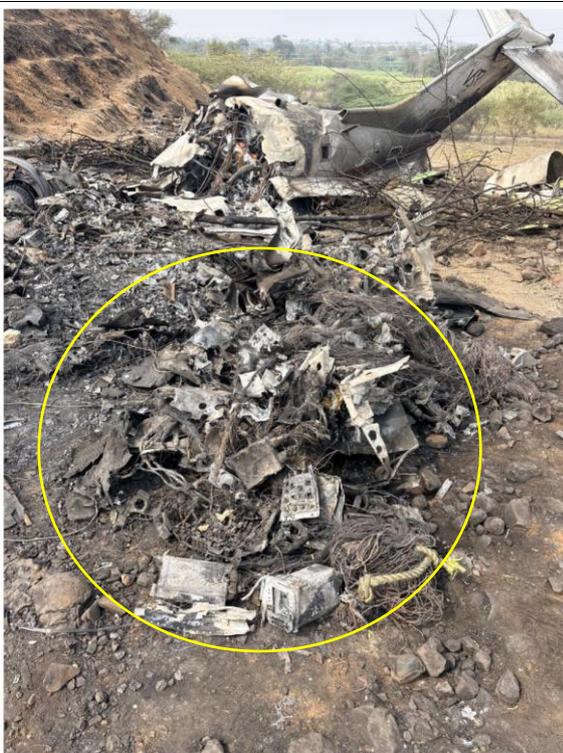
**Cockpit Wreckage**

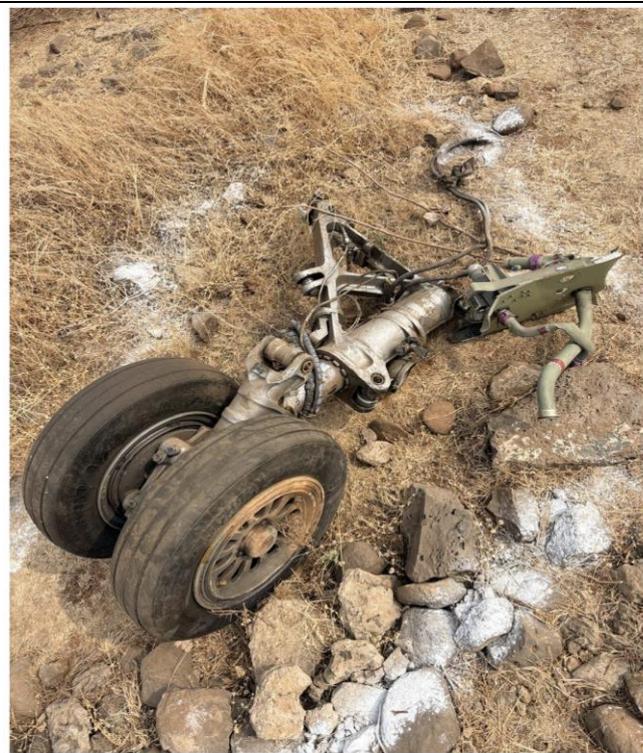
**RHS Landing Gear and Airframe Fuel Filter Towards Left**

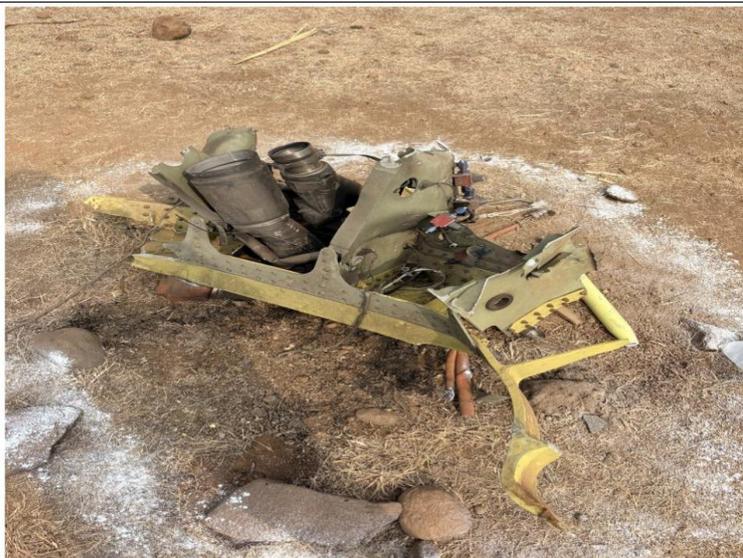
Part of Lower Mid fuselage

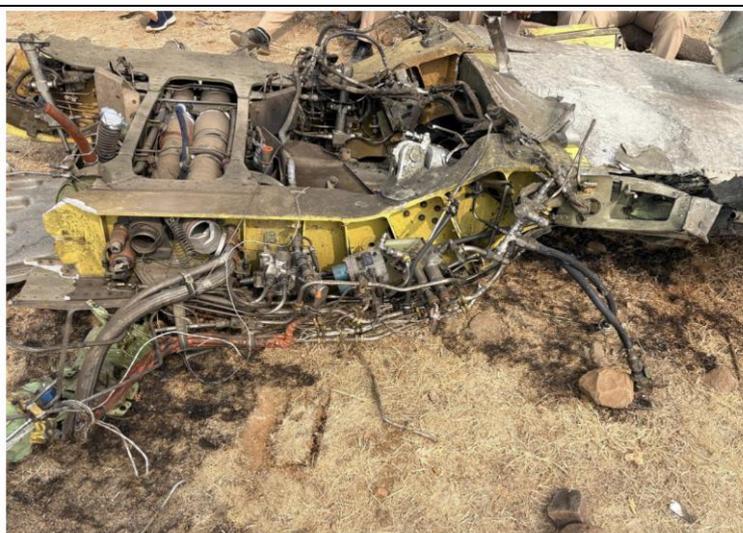
**RH Wing along with Landing Gear Bay area, Airframe Fuel Filter and flap mount attachment**

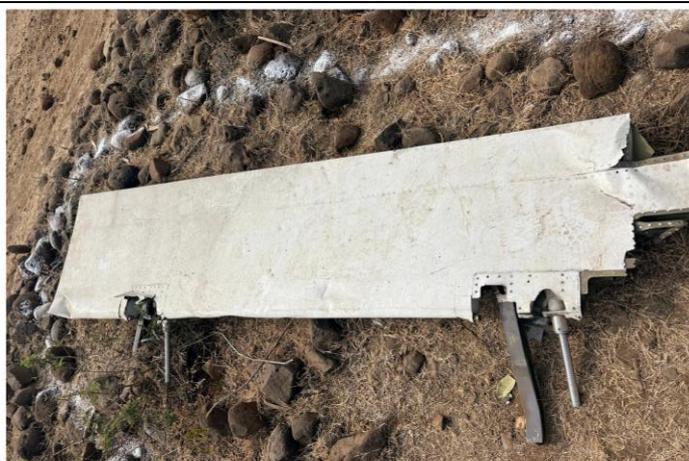
**Part of RH Flap**

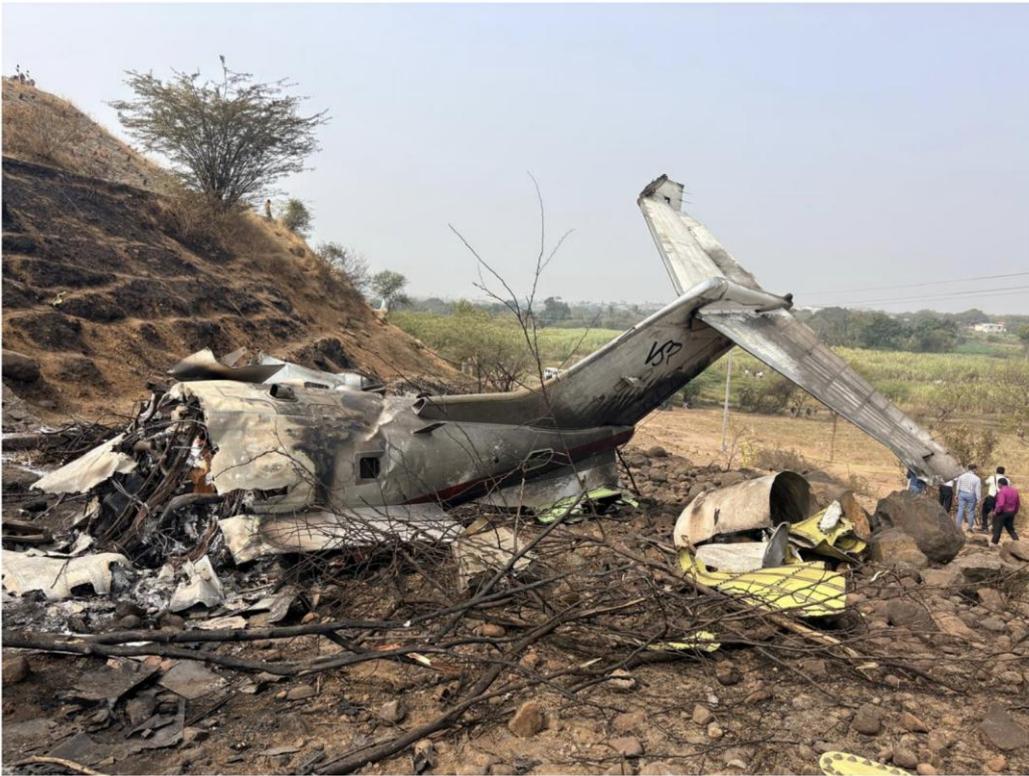
Empennage

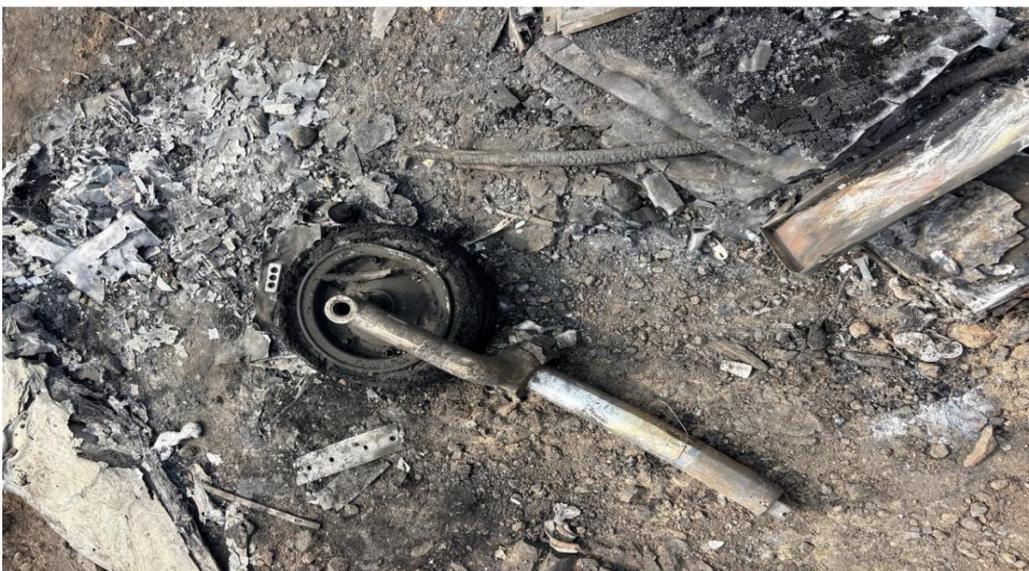
Nose Landing Gear

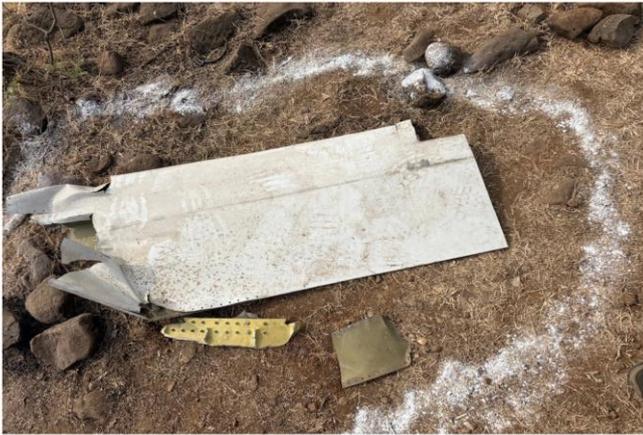
Rest Part of the RH flap

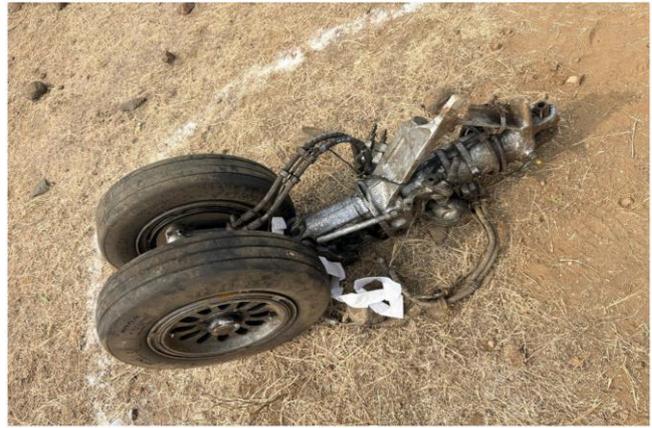
**LH Landing Gear**

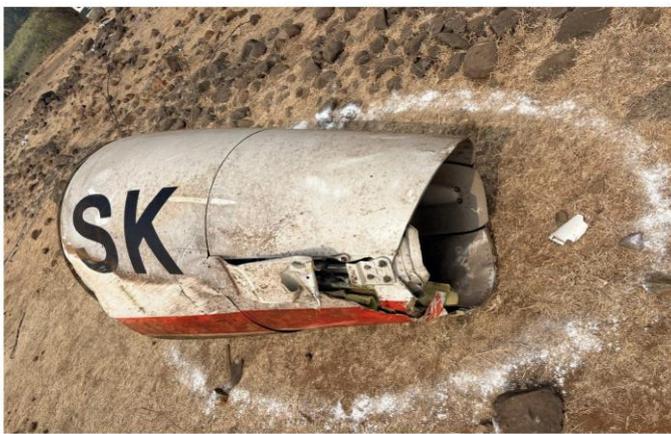
**LH Thrust Reverser**

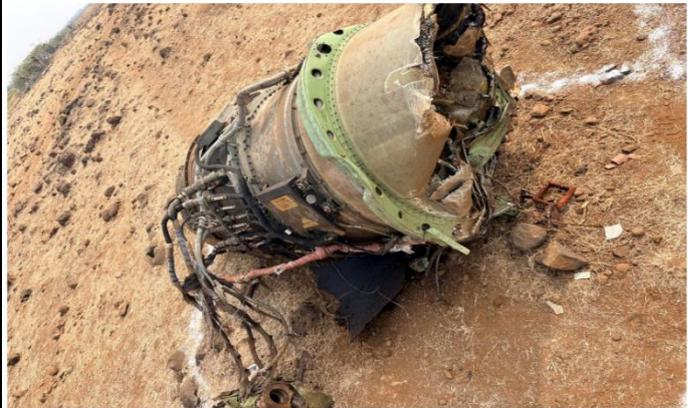
**LHS Engine**
